**National Transportation Safety Board
Office of Railroad, Pipeline &
Hazardous Materials Investigations
Washington D.C.**

**Factual Report of Investigation
Railroad Signals**

NTSB Number:
DCA-08-MR-007

Location: Newton, Massachusetts
Date: May 28, 2008
Time: 5:51 p.m. eastern daylight time (EDT)¹
Carrier: Massachusetts Bay Transportation Authority
Trains: Trolley Train 3667 (3667 lead unit, 3706 articulated unit)
Trolley Train 3681 (3681 lead unit, 3703 articulated unit)

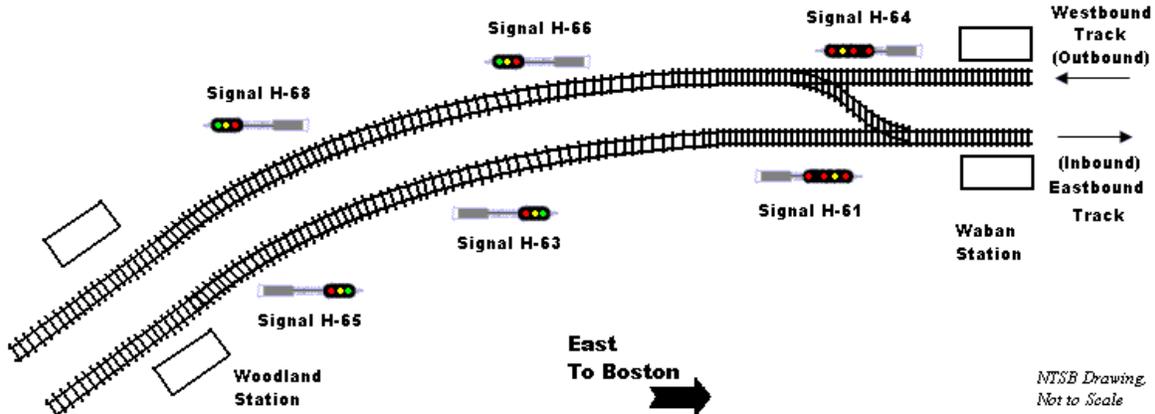
Signal Layout

The MBTA, D Branch (Highland Branch) of the Green Line runs in a geographic east-west direction between Cambridge (Lechmere Station) and Newton (Riverside Station) in Massachusetts. In the vicinity of the accident, the track structure consists of double track territory. The maximum authorized speed on the double tracks is 40 mph with a posted 25 mph speed restriction over the crossover switches.

Train movements on the Highland Branch are governed by the MBTA light rail rule book for operators and the signal indications of an automatic block signal (ABS) system. The ABS system utilizes five aspect US&S colorlight type signals and US&S hand operated switch machines operating in conjunction with 25 hertz AC track circuits.
